Sperian Respiratory Protection USA, LLC - 3001 South Susan St - Santa Ana, CA 92704

IMPORTANT SAFETY NOTICE Concerning SPERIAN Warrior SCBA Heads-Up Display (HUD) Cable Connection

December 2, 2008

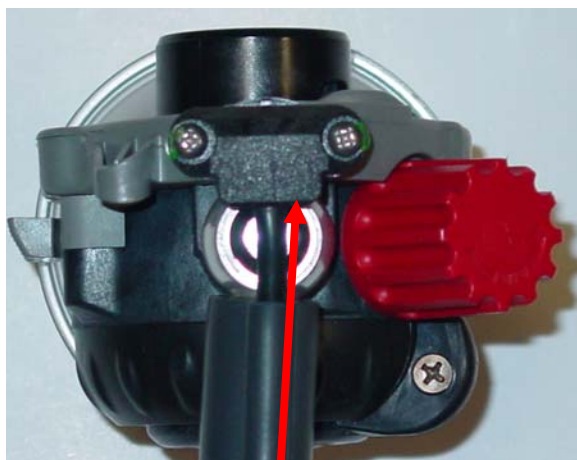
Figure 1 Old cable assembly.

Sperian has determined through examination of some WARRIOR warranty returns that HUD lights did not work correctly. The cause was determined to be the cable assembly that attaches to the HUD. While this condition has been seen on only a few Warriors shipped, and there have been no injuries reported, the cable assembly has been redesigned to eliminate this potential problem. Figure 1 below shows the original cable assembly and Figure 2 shows the new cable assembly. Note that the new cable connector has a rounded edge where the old cable connector had a square edge.

Old connector
Square edge

Sperian will replace under warranty the cable assemblies on all WARRIORS that were made with the old cable assembly.

Examine the cable assembly connector and determine if your WARRIORS have the old cable assembly. If they do, contact a Sperian warranty center to arrange to have the cable assemblies replaced. (Note that Sperian technicians certified for Panther repair, but not yet certified for WARRIOR repair, are authorized to perform this upgrade, because the procedure for replacing the WARRIOR HUD cable/hose assembly is the same as for the Panther. They may also run the PosiChek tests necessary to verify this upgrade but may make no further adjustments to the WARRIOR SCBA.)

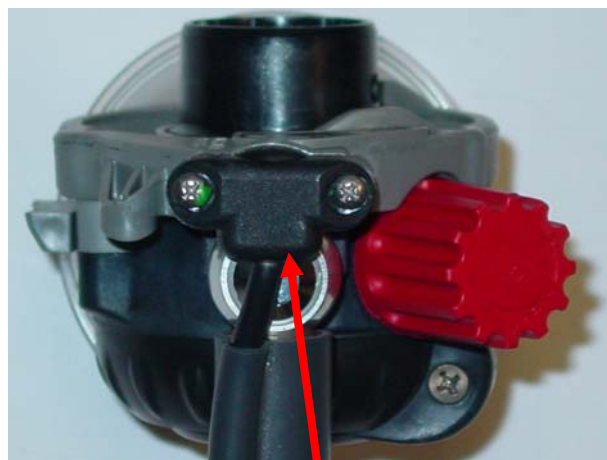
Figure 2 New cable assembly.

New connector
Rounded edge
