INFORMATION NOTICE

To: All Users of Survivair® Panther™ and Cougar™ Self-Contained Breathing Apparatus (SCBA) and Sperian Warrior™ SCBAs Equipped with the Survivair and Sperian Rapid Intervention Crew/Company Universal Air Connection (RIC UAC) High Pressure Male Coupling

SPERIAN/SURVIVAIR UAC (Universal Air Connection)

How to Inspect the Sperian Warrior UAC Coupling Date Code

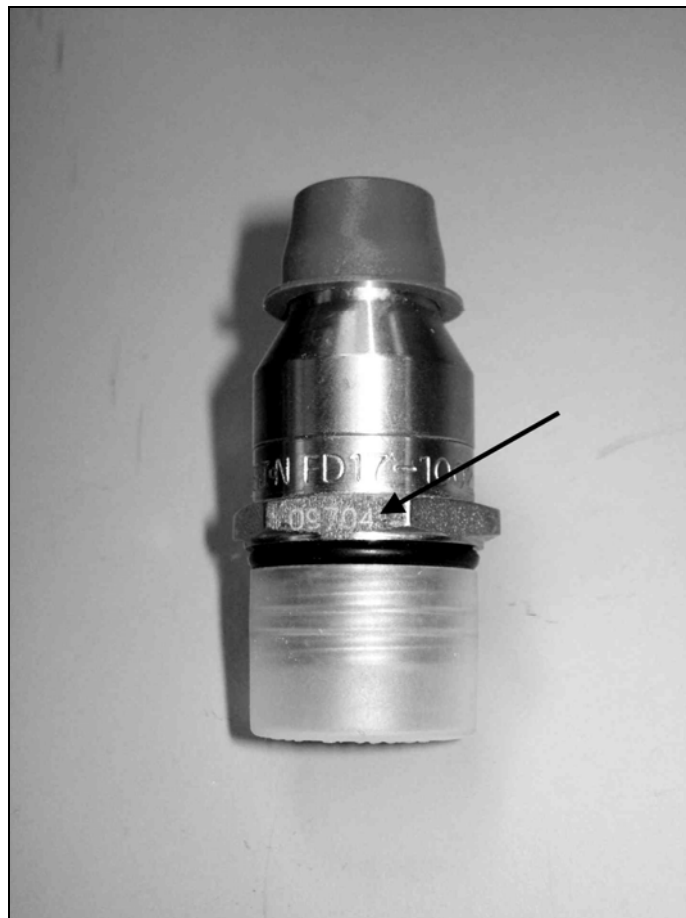
Figure 1

Our coupling supplier has identified four (4) specific date codes that need to be returned for evaluation. These date codes are located on the coupling as shown in **Figure 1**. The date codes are: **06508**, **06608**, **06708**, and **06808**.

Please inspect the UAC coupling on your SCBAs. If you have Sperian Warrior SCBAs, follow the instructions in the attachment to this notice entitled, "How to Inspect the Warrior UAC Coupling Date Code." If you find the date codes as specified above, remove the SCBAs from service immediately and have the UAC coupling replaced by a Sperian-certified technician before the SCBA is put back into service. Contact your local Sperian Respiratory Warranty Service Center for replacement couplings if you employ a Sperian-certified repair technician or have the Warranty Service Center perform the inspection and replacement. Any UAC (Universal Air Coupling) High Pressure Male Coupling, Sperian part number 961483, found to have the date codes listed above will be replaced under warranty regardless of age. Our vendor has rectified this situation, which eliminates the potential for any future problems.

Alternatively, pressurize the UAC coupling, using a Sperian or Survivair RIT Kit. Ensure that the incoming pressure is at least 2500 psig. Verify that the connection between the fill hose and the UAC coupling can be made, and check for audible leaks from the male coupling. If the connection cannot be made, or if leaks are present, remove the SCBAs from service immediately and have the UAC coupling replaced by a Sperian-certified technician before the SCBA is put back into service. Contact your local Sperian Respiratory Warranty Service Center for replacement couplings and replacement screws if you employ a Sperian-certified repair technician or have the Warranty Service Center perform the inspection and replacement. Any UAC (Universal Air Coupling) High Pressure Male Coupling, Sperian part number 961483, found to have the date codes listed above will be replaced under warranty regardless of age.
