June 16, 2006

URGENT SAFETY NOTICE

- Survivair Panther TwentyTwenty Plus® CBRN Facepiece nozzle found on 2420XX series facepieces.
- Survivair Panther TwentyTwenty Plus® CBRN Facepiece Air Klik found on 2420XX series facepieces.
- Survivair Panther TwentyTwenty Plus® Facepiece nozzle found on 2220XX, 2320XX, 2520XX, and 2620XX series facepieces.

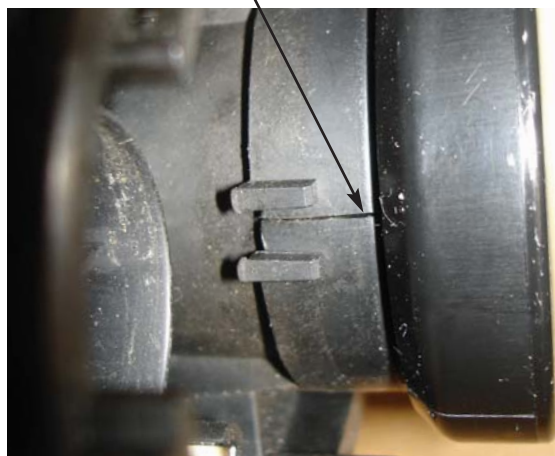
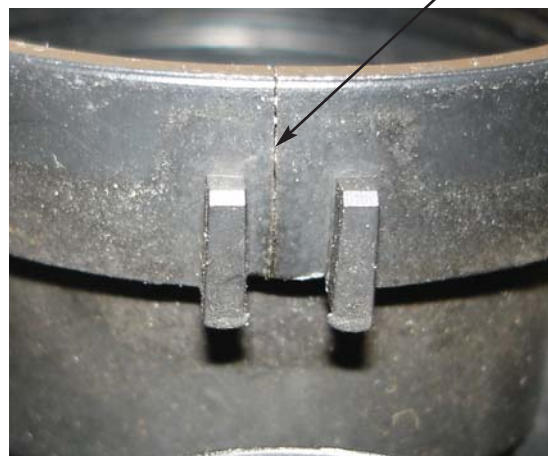
Figure 1

It has been determined that the Survivair TwentyTwenty Plus® Facepiece nozzle has the potential to crack at the molding knit line if the Air Klik is over-tightened as shown in **Figure 1**. Please note that the mold knit line as shown in **Figure 2** is normal and acceptable as long as the plastic has not cracked and separated as shown in **Figure 1**. If you are uncertain as to whether there is a normal knit line or a crack in your nozzle, attempt to spread the plastic apart. If it is a crack, the plastic will separate.

Crack spread open due to over-tightened Air Klik

Crack without Air Klik

Inspect your 2420XX series facepieces to see if they have a crack in the nozzle as shown in **Figure 1**. If any of the facepieces have a crack in the nozzle as shown in **Figure 1**, remove them from service and replace the nozzle with a new modified nozzle and Air Klic prior to returning the facepiece to service. If any of your 2420XX facepieces **DO NOT** have the modified nozzle as shown in **Figure 3**, and **DO NOT** have a crack in the nozzle as shown in **Figure 2**, they may be put back into service temporarily, but only until the nozzle can be replaced with a new modified nozzle and Air Klic. Contact Survivair by fax using the attached Fax Form to receive nozzle and Air Klic replacement kits.

Survivair advises all users of Panther TwentyTwenty Plus® Facepieces, series number 2220XX, 2320XX, 2520XX, and 2620XX, that if your facepiece fails a negative pressure fit check, inspect the nozzle for a crack as shown in **Figure 1**. Survivair will replace all cracked nozzles under warranty regardless of purchase date. Contact Survivair by fax using the attached Fax Form to receive replacement nozzle kits.

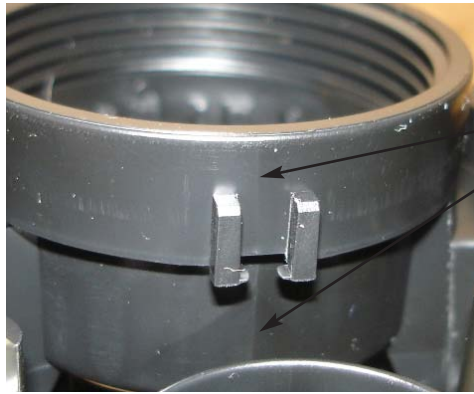
Figure 2

Normal knit line (note: no visible separation)

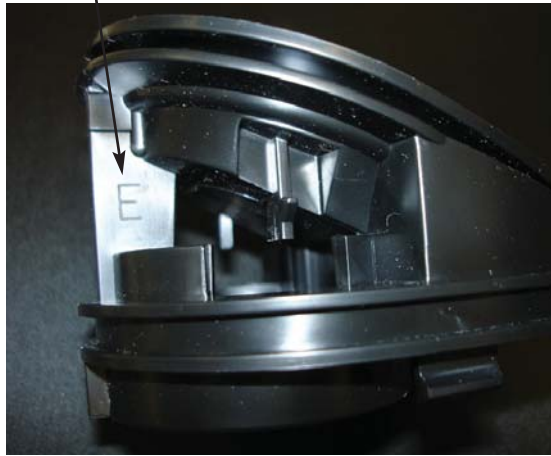
Figure 3

Modified nozzles have an "E" marked on the web as shown

Please inspect your 2420XX series facepieces to see if they have the new, modified nozzle as shown in **Figure 3** (the nozzles are marked with an "E" as shown) and the correct CBRN Air Klic as identified in **Figure 4**. If your facepieces have the modified nozzle as shown in **Figure 3**, and correct Air Klic as shown in **Figure 4**, these parts do not need to be replaced, and you may return the facepieces to service.

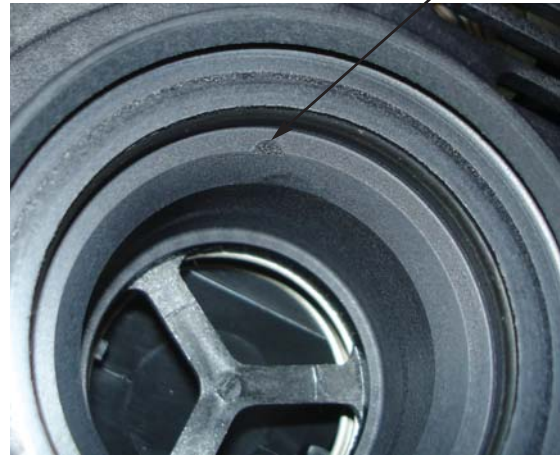
Figure 4

Survivair has also received at least one report of the second stage regulator being difficult to install into the CBRN facepiece. An investigation of that report revealed that the o-ring groove on the facepiece Air Klic was machined slightly shallow. This combined with the stiffness of the EPDM o-ring material used in the CBRN version of the Air Klic, made the regulator slightly more difficult to install into the CBRN facepiece than in the non-CBRN facepiece. Current facepieces have Air Klics with the correct o-ring groove diameter. These Air Klics are marked with a half-moon shaped visible identifier when looking at the front of the Air Klic. See **Figure 4**.

Half-moon shaped Air Klic identifier
